PROPERTY INSPECTION REPORT

TEC Property Inspections

Date of Inspection: 4/21/2025

Year Built: 2025

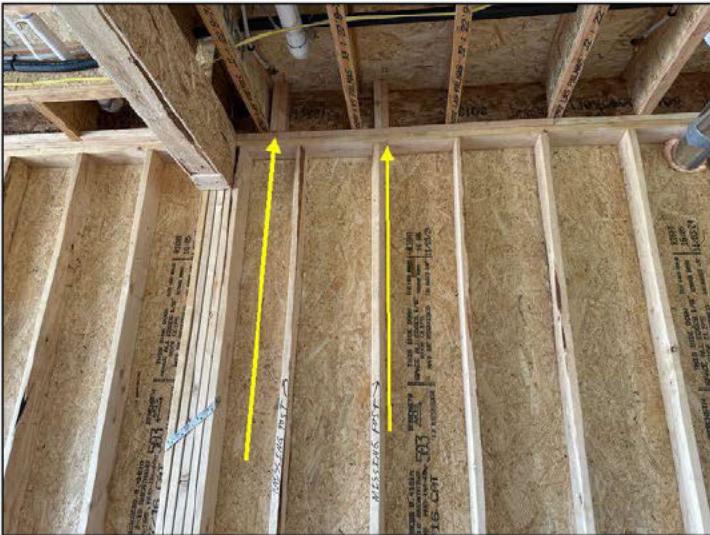
Missing posts for squash blocks north wall garage east of the I beam

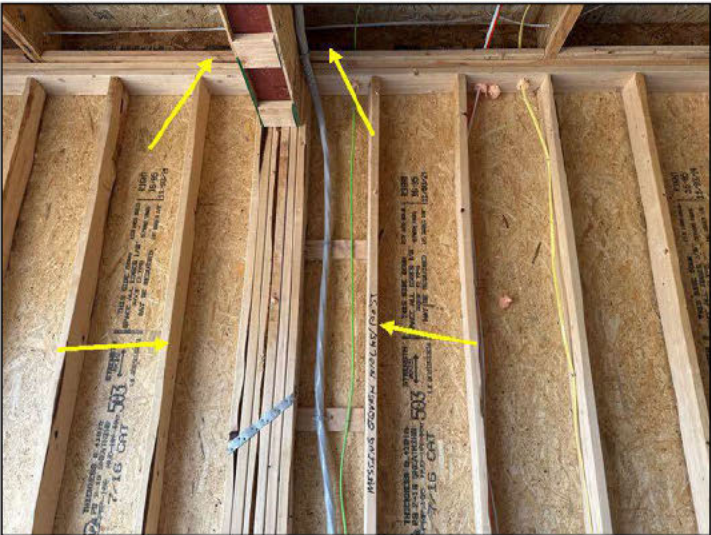
Missing squash blocks/post north wall west of the I beam

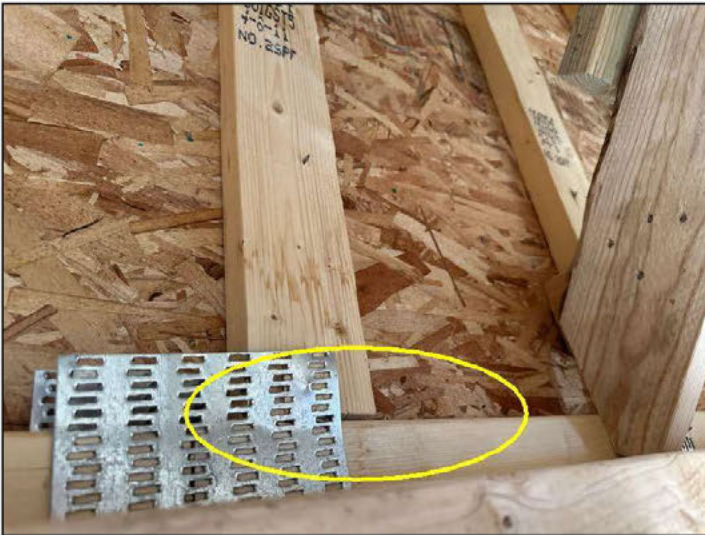
West end gable gusset plate not covering truss member

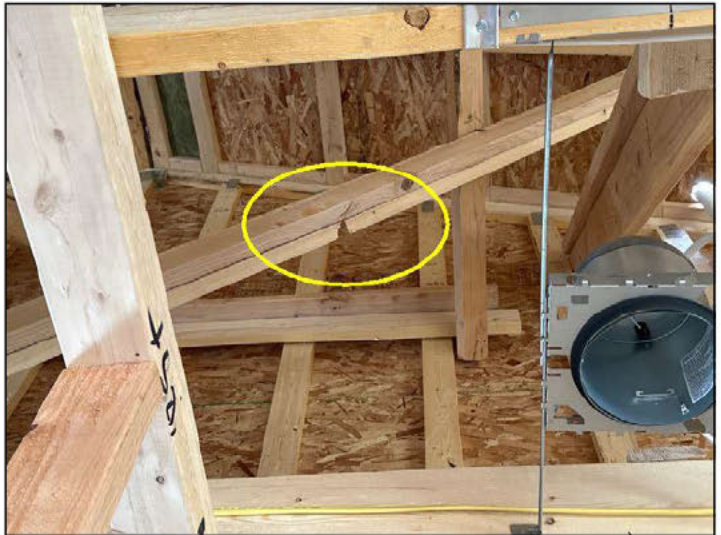
Second truss in from the north is broken with improper fix from the framer

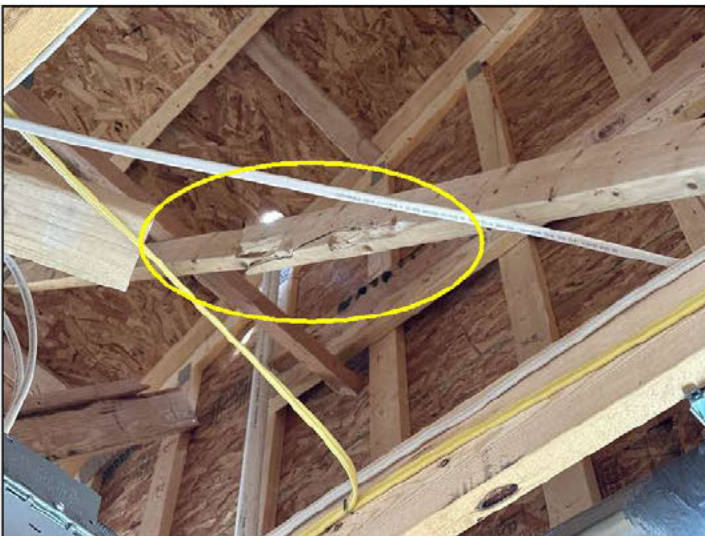
Second truss in from the north had a broken web 2x4

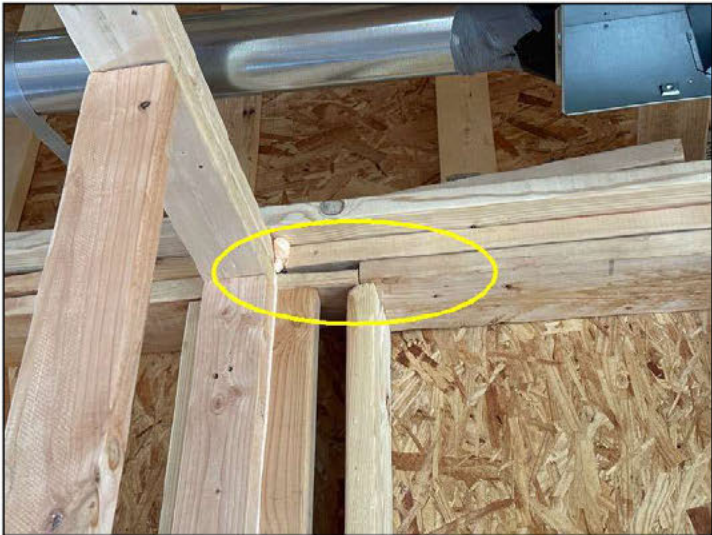
Strap needed at plate break north-west corner primary toilet

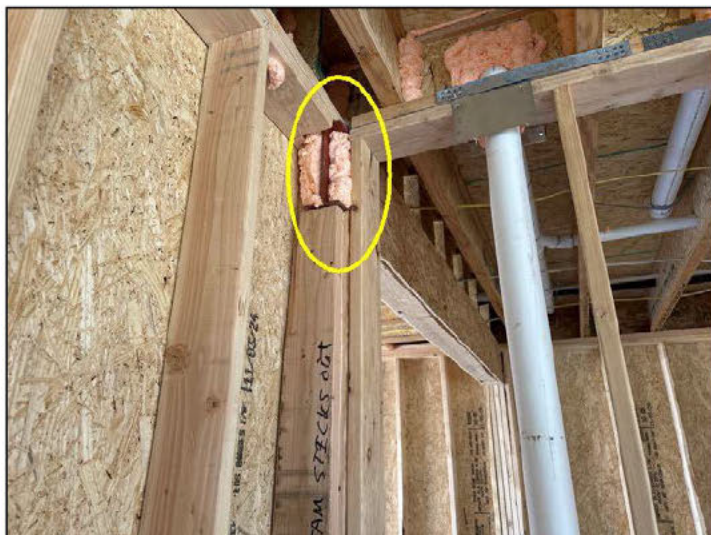
Inside north-west corner beam sticks out of the plates

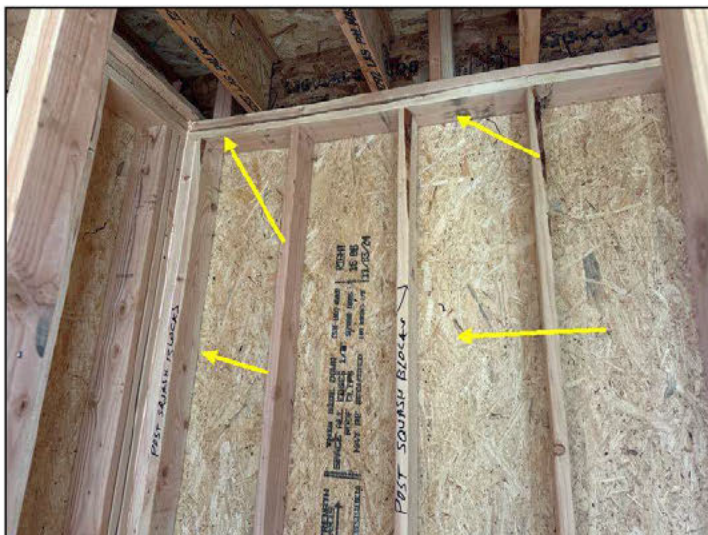
Post squash blocks north wall in pantry

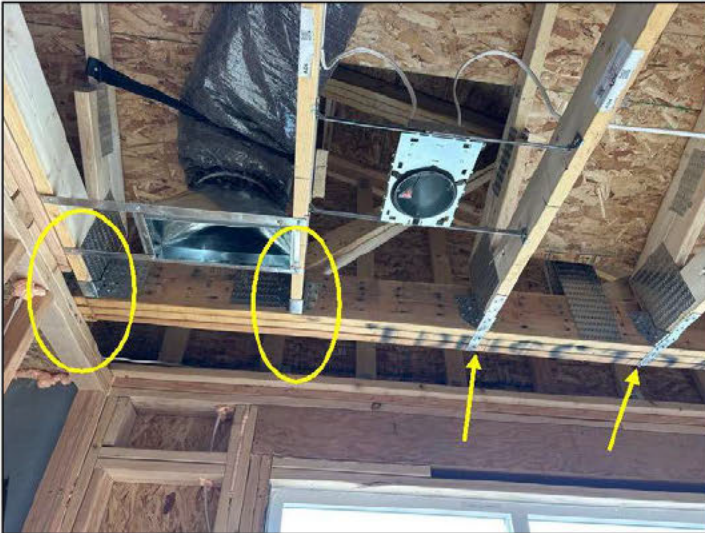
Missing straps near east window primary bedroom truss to girder

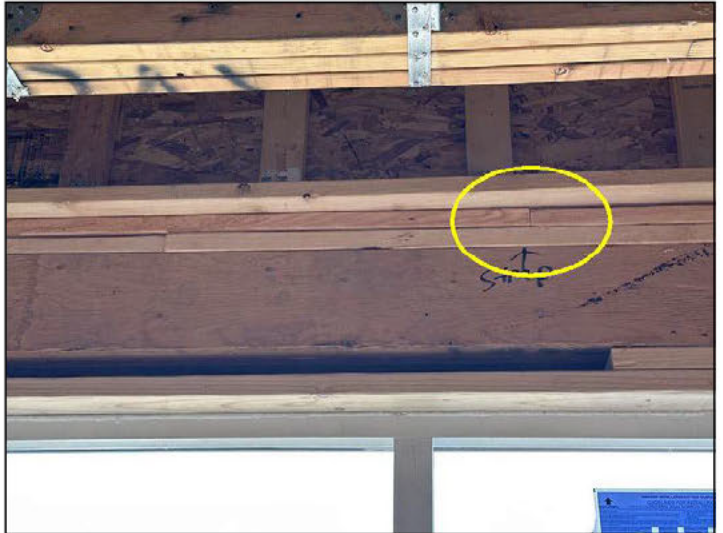
Missing strap at plate break east wall above primary bedroom window

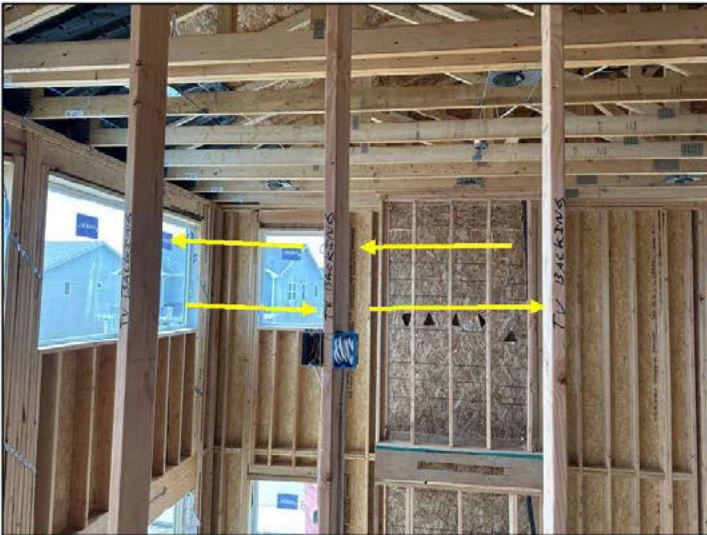
Add TV backing south wall primary bedroom

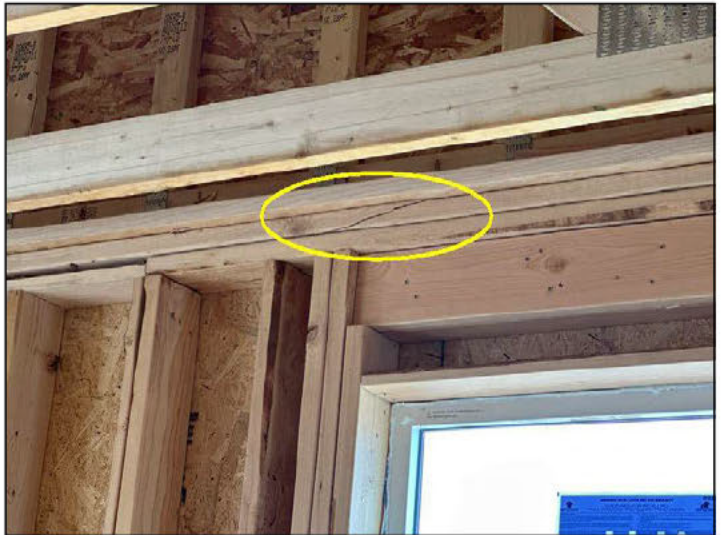
Missing plate break strap top of the south balloon wall west of fireplace

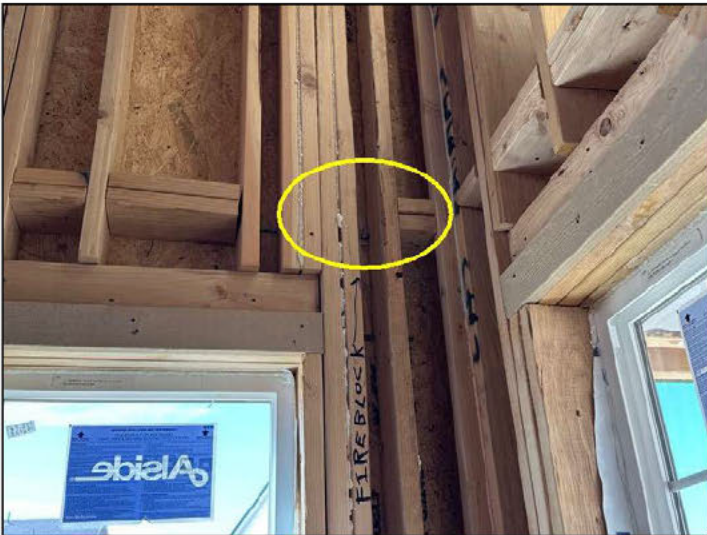
Missing 10' fire block south-west corner above the stair landing

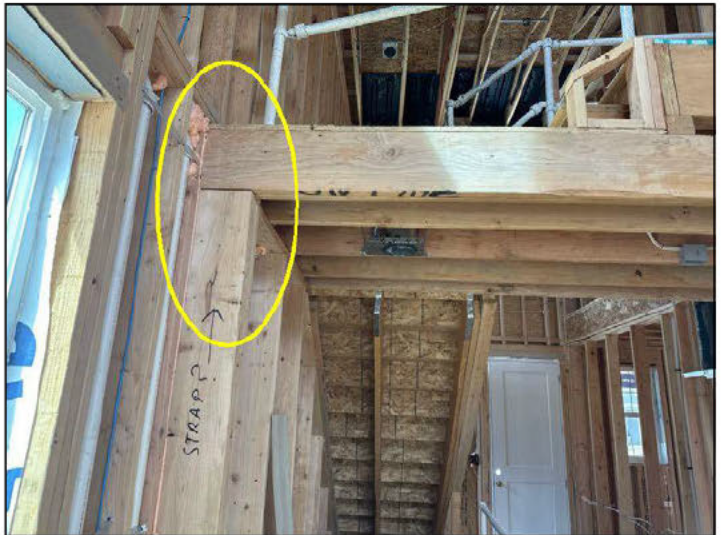
Missing strap west wall near south exterior wall stair landing

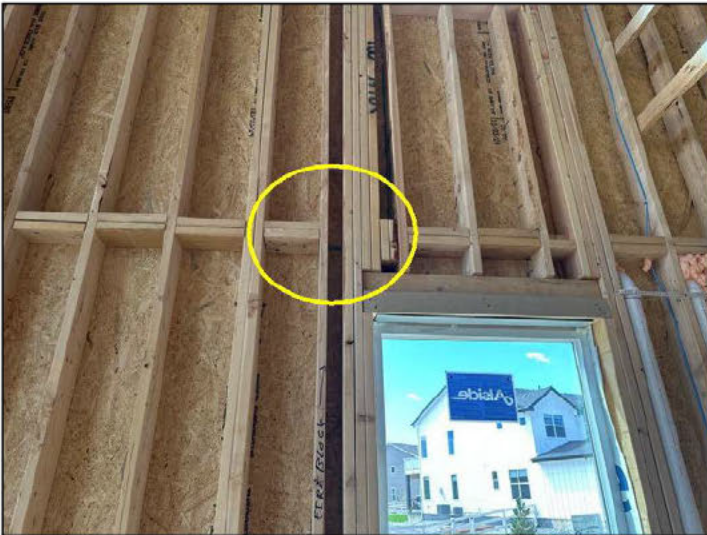
Missing 10' fire block south wall west of fireplace

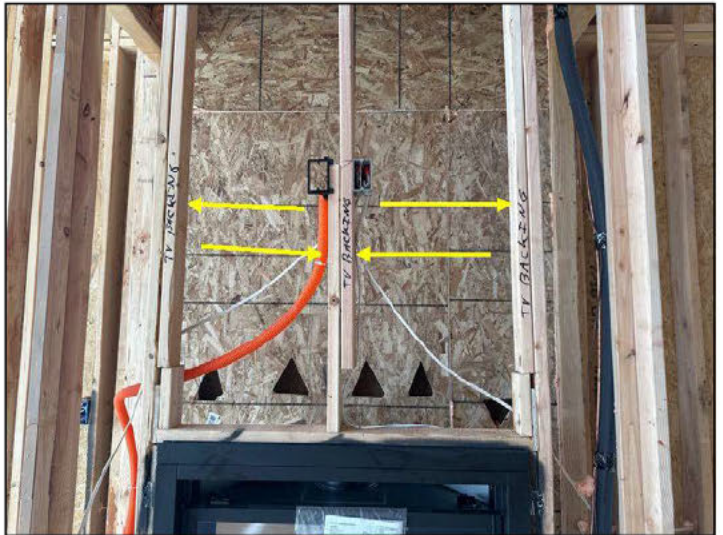
Add backing for TV south wall above the fireplace

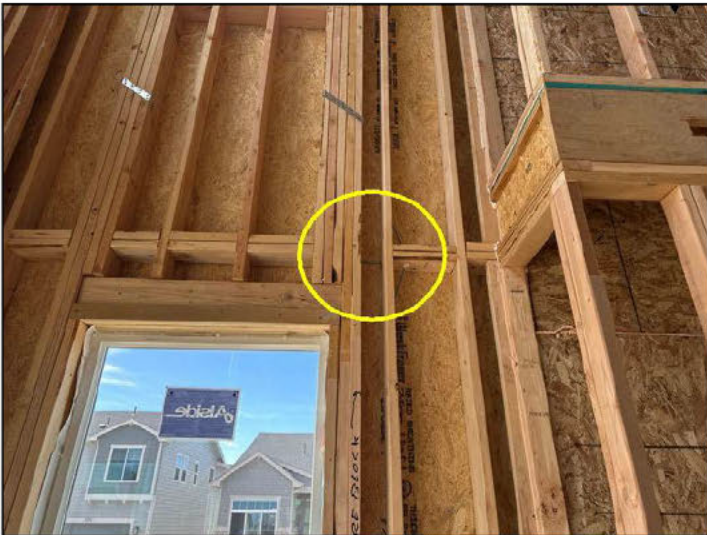
Missing 10' fire block living room south wall east of fireplace

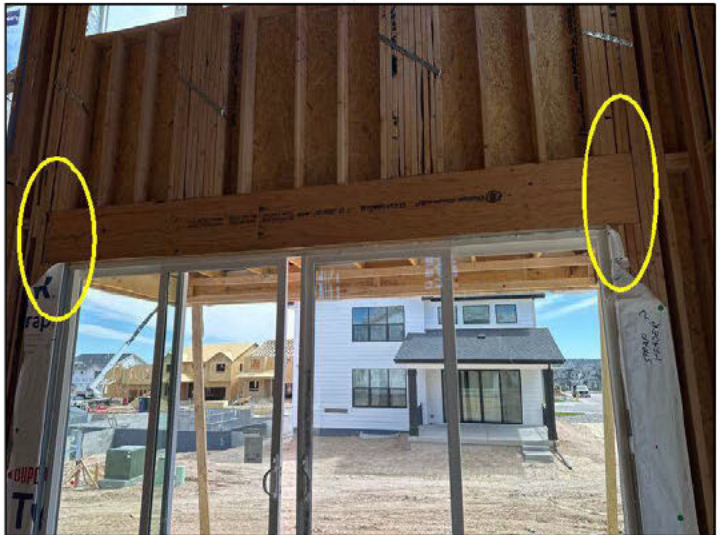
Strap headed over the sliding glass door

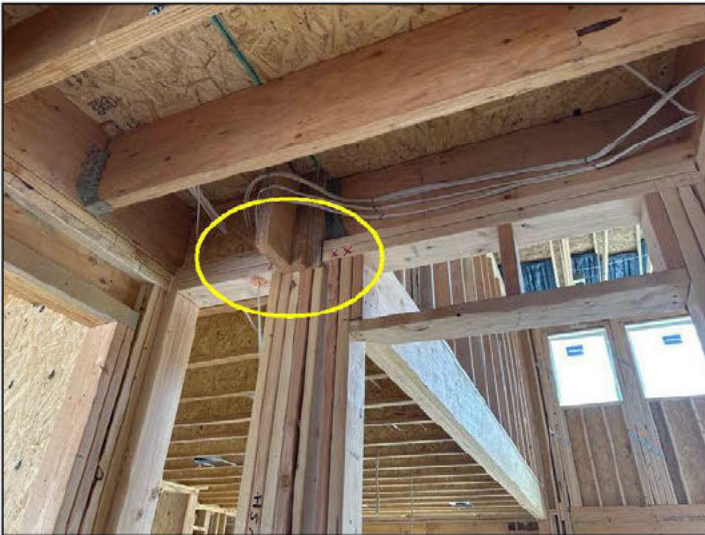
Cut LVL flush east wall mud room

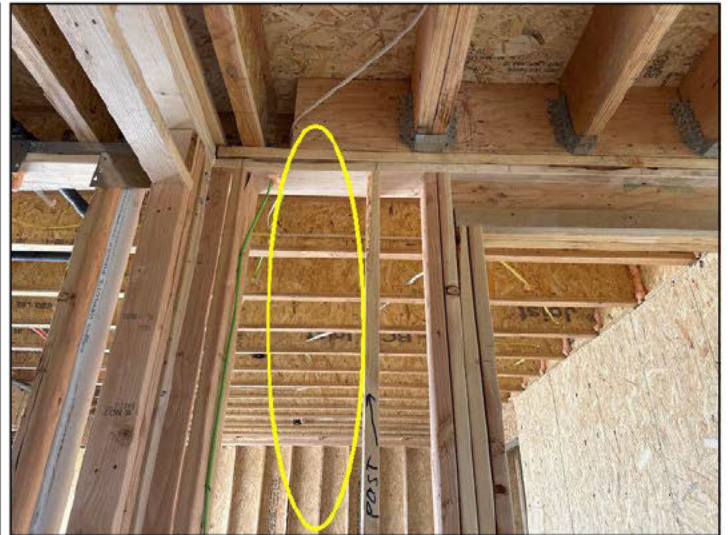
Missing post north wall mud room west of garage occupant door

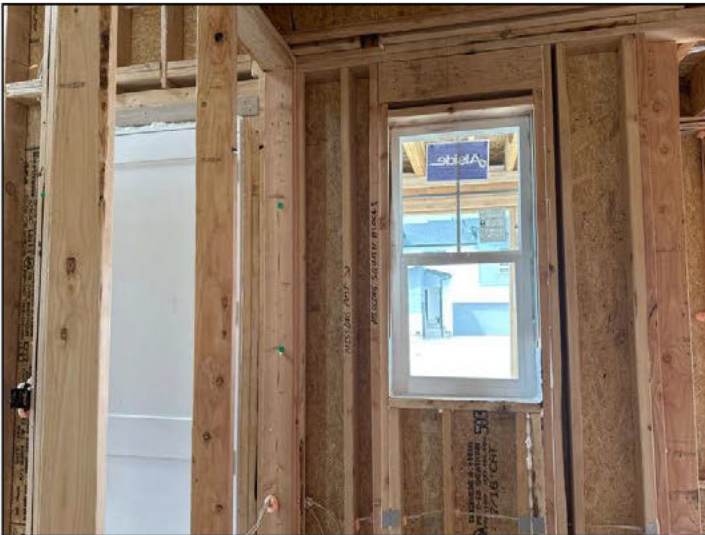
Missing squash blocks and post west wall office south of the window

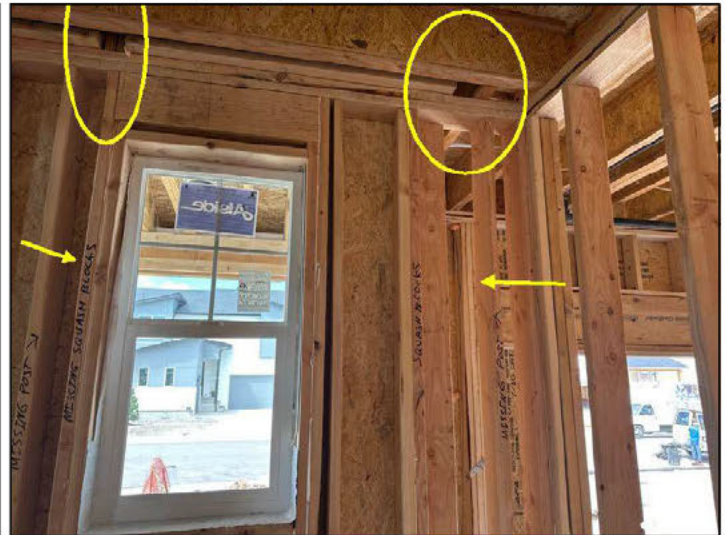
Missing squash blocks and post west wall office north of the window

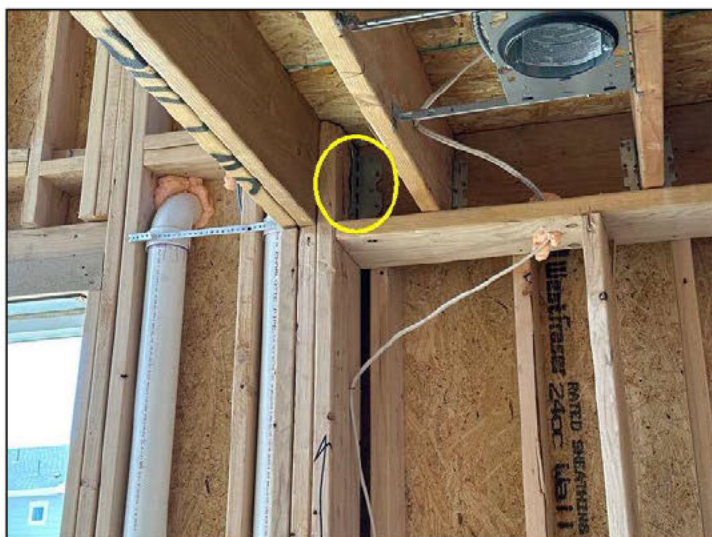
Missing nails upper south-east corner stair landing LS70

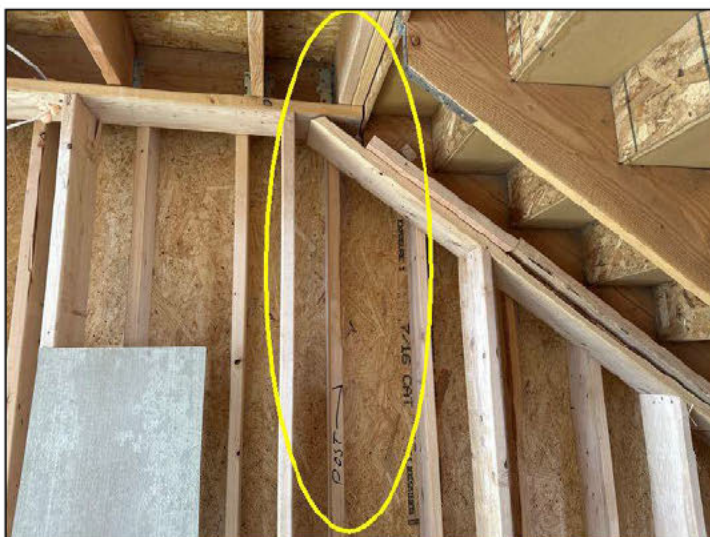
Missing post south wall at the top of the basement stairs for the second floor stair landing beam

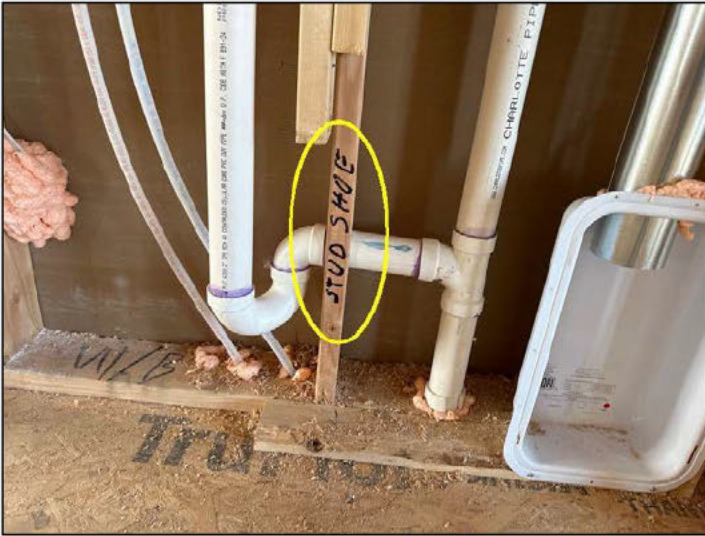
Missing stud shoe at plumbing south wall laundry

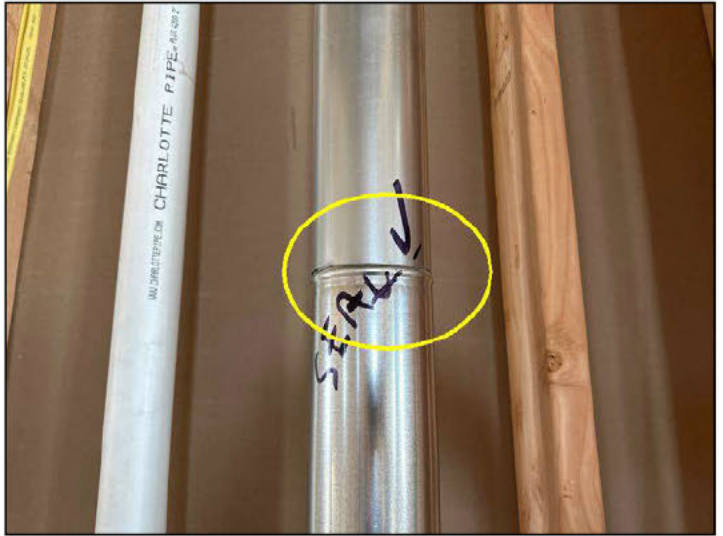
Seal seam at the dryer vent

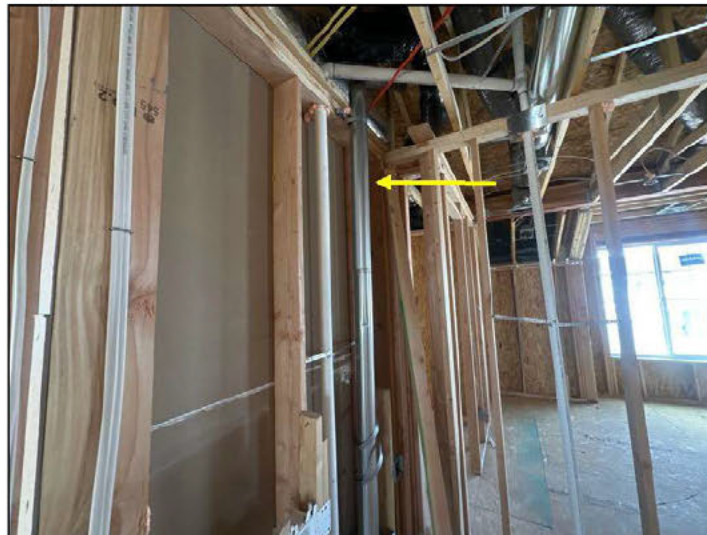
Recess dryer vent south wall

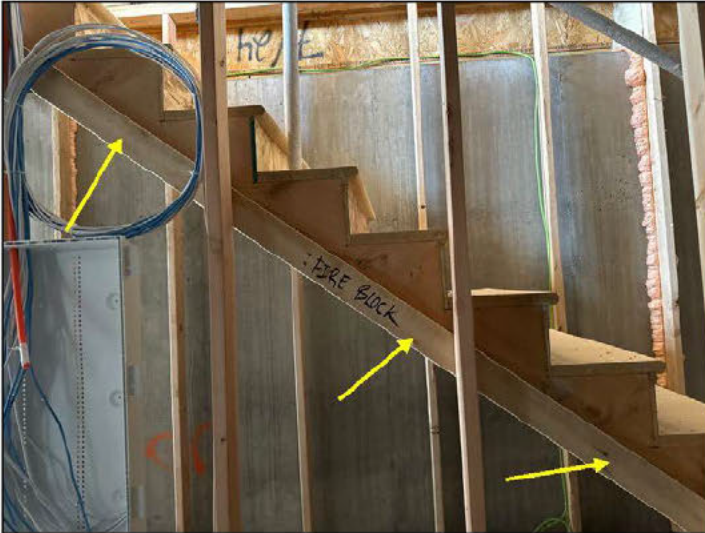
Missing fire block at the stair stringer both sides

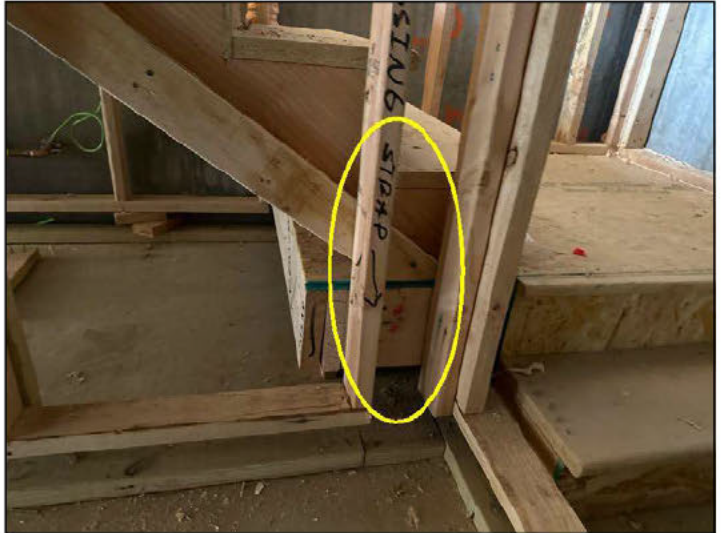
Basement stair landing not strapped

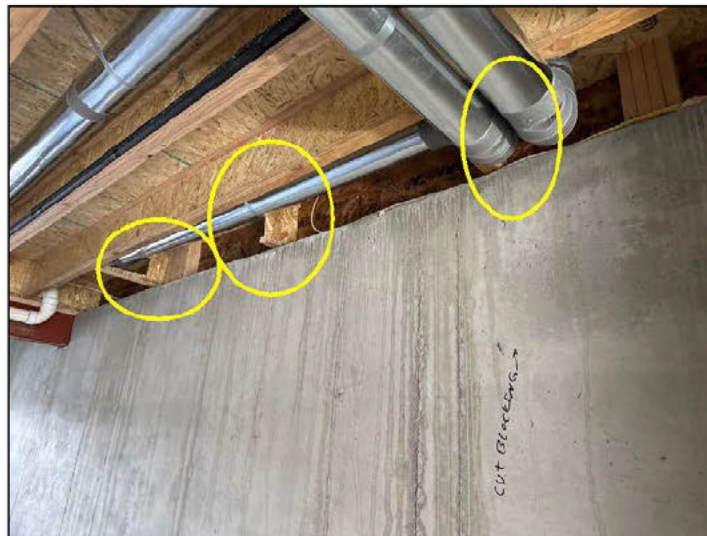
East wall tinner cut out blocking

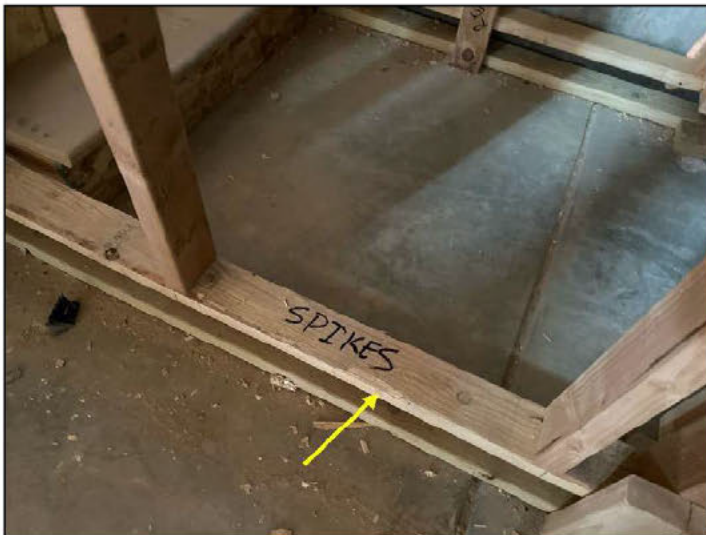
Missing spikes in the floating wall

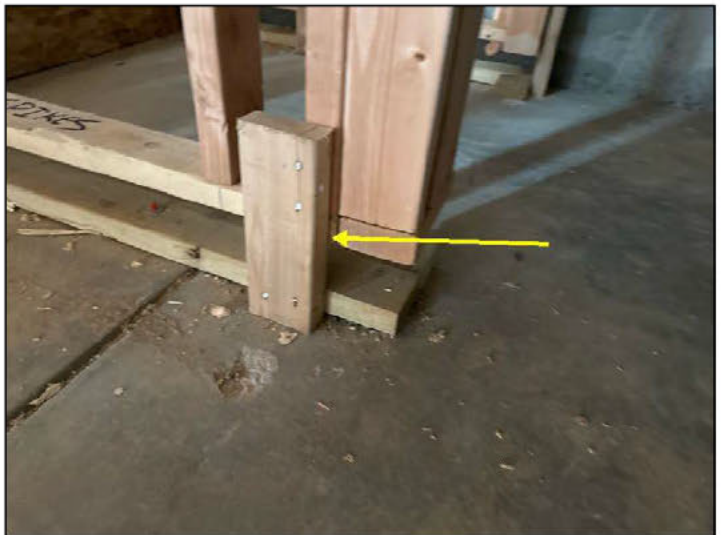
Remove temp blocks after spikes are in

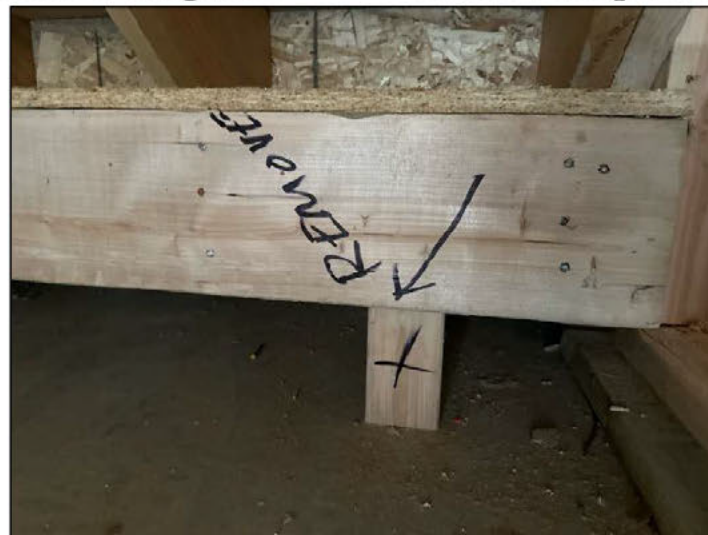
Remove temp block under the west end of the basement stair landing after straps are added

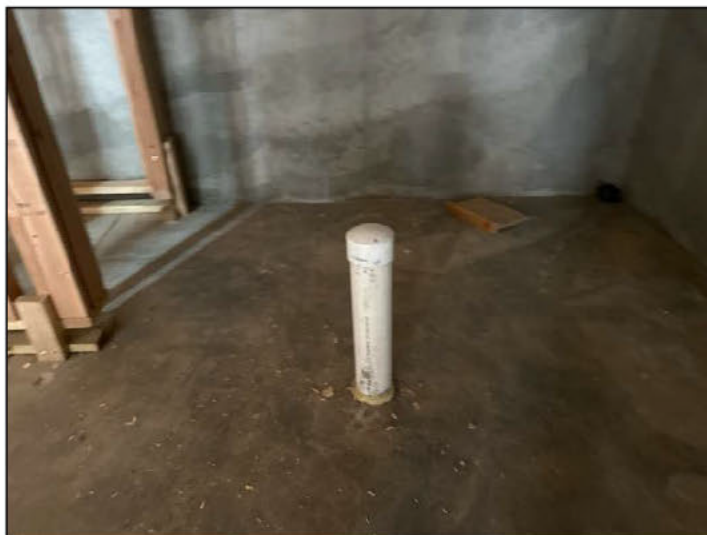
• What is the **PVC** at the bottom of the stairs for?
