# PROPERTY INSPECTION REPORT

Date of Inspection: 9/29/2021

Tom Glassburn **TEC Property Inspections and Radon Mitigation**

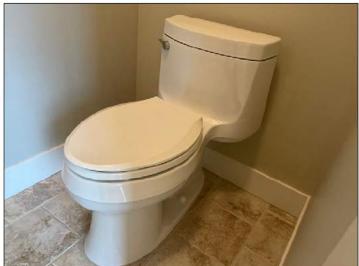
• The toilet seat was loose. A qualified contractor should evaluate and repair or replace as necessary.

Seat is loose on one side

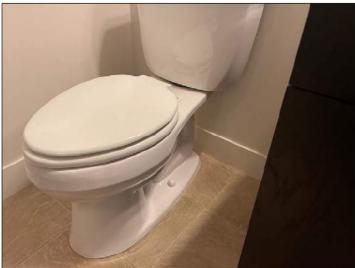
• The toilet continually "runs" after flushing. This generally means the interior tank components are not working properly. A qualified contractor should evaluate and repair or replace as necessary.

Toilet continuously runs

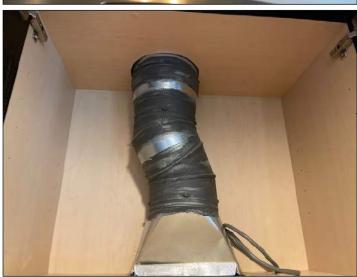
- Manufacturer: General Electric
- Range Hood Type: Combination Microwave/Vent Hood
- The vent hood was missing a vent cover. A qualified contractor should evaluate and repair or replace as necessary.

Missing a filter/vent cover

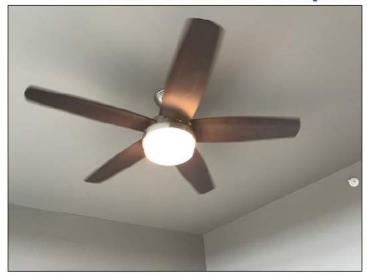
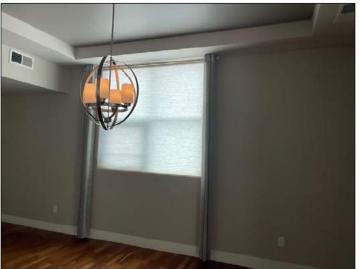
• The dimmer light fixture in the dining room did not fully turn off the light. A qualified contractor should evaluate and repair or replace as necessary.

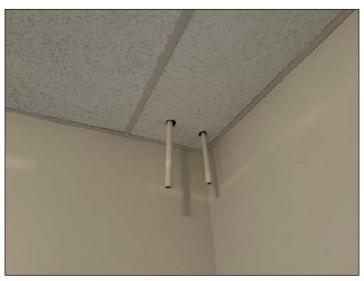
• The condensate pump discharge location, for both Fan Coil systems, was in the laundry room, from the ceiling. Be aware if there is a condensation leak, it will drip in the laundry room.

Condensation tray for both Fan Coil systems drain here
