# PROPERTY INSPECTION REPORT

Date of Inspection: 9/29/2021

Tom Glassburn **TEC Property Inspections and Radon Mitigation**

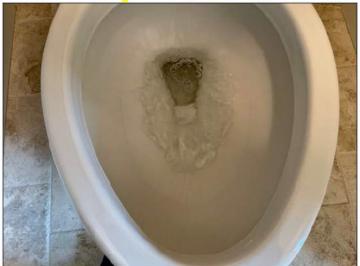
• The toilet seat was loose. A qualified contractor should evaluate and repair or replace as necessary.

Seat is loose on one side

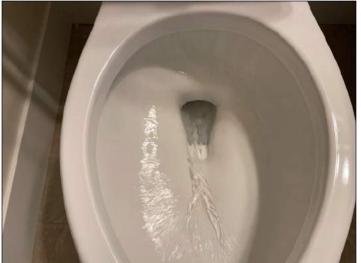
• The toilet continually "runs" after flushing. This generally means the interior tank components are not working properly. A qualified contractor should evaluate and repair or replace as necessary.

Toilet continuously runs

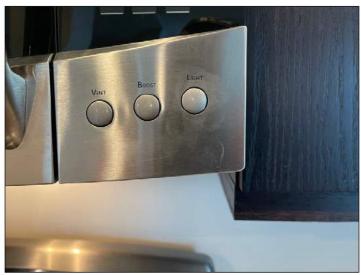
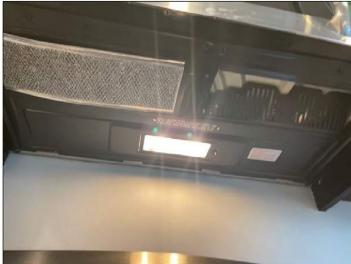
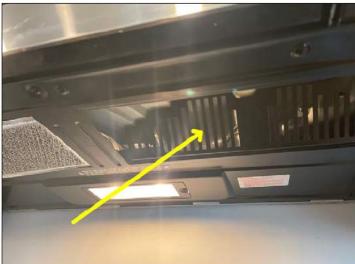
- Manufacturer: General Electric
- Range Hood Type: Combination Microwave/Vent Hood
- The vent hood was missing a vent cover. A qualified contractor should evaluate and repair or replace as necessary.

Missing a filter/vent cover

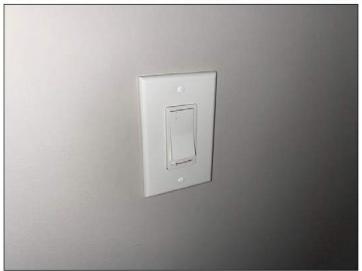
• The dimmer light fixture in the dining room did not fully turn off the light. A qualified contractor should evaluate and repair or replace as necessary.

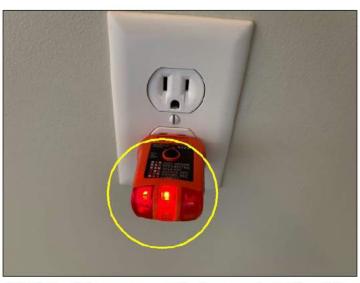
• An electrical outlet, in the office on the north wall, was wired incorrectly with reversed polarity. A qualified contractor should evaluate and repair or replace as necessary.

Outlet with reverse polarity north wall of the office

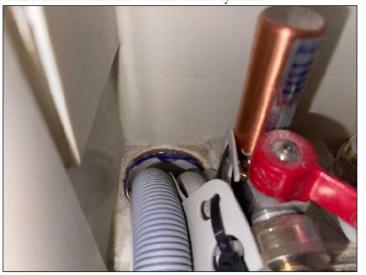
• The majority of the washer drain system was not visible and could not be inspected for proper operation. Inspection of the washing machine (if present) is beyond the scope of this inspection. The washing machine (if present) was not operated and the inspector is unable to determine if there are any deficiencies with the washer drain system.

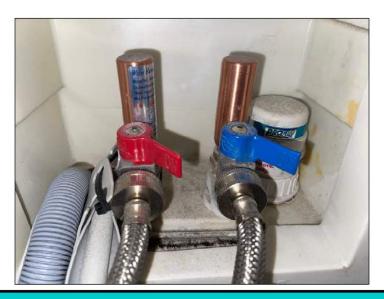
• The water shut off valves for the clothes washer appeared to be in serviceable condition at the time of inspection. They were not operated but were visually inspected.

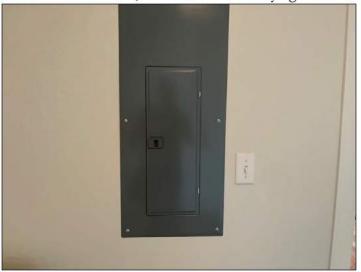
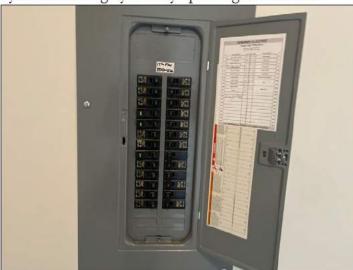
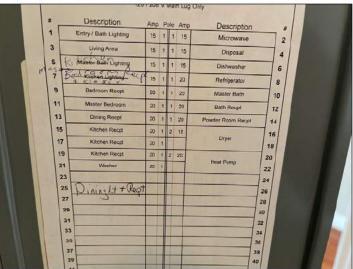
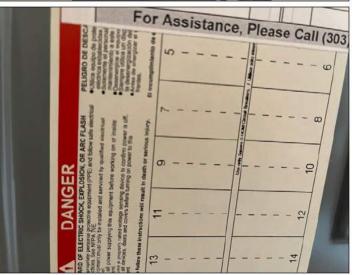
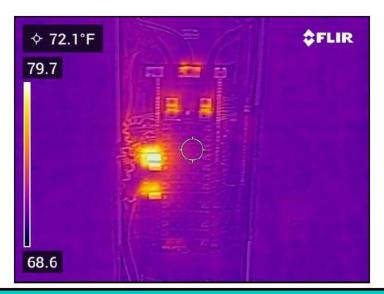
• The electrical distribution panel installation and condition was inspected, and found to be in satisfactory condition at the time of inspection.

• The manufacturer's label was present at the main electrical service panel. The manufacturer's label typically provides information describing the main panel such as the name of the panel manufacturer, the panel model number, the panel amperage rating, limitations related to the environment in which the panel was designed to be installed and grounding/bonding information for that particular model.

• The circuit label for the main electrical service panel is shown in the photo. Circuits in the main service panel were labeled. The accuracy of the labeling was not verified. When the opportunity arises, we recommend verifying the accuracy of the labeling by actually operating the breakers.

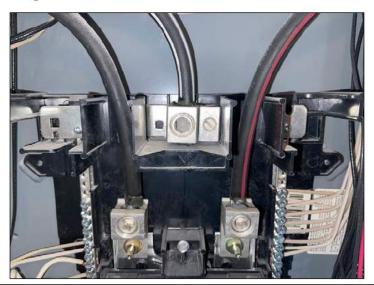
• Electrical service-entrance conductors were inspected and found to be in satisfactory condition at the time of inspection.

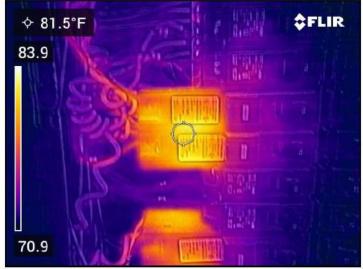
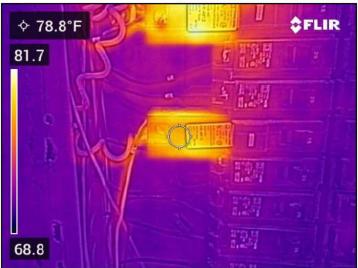
• Electrical over-current protection devices (circuit breakers and fuses) were not tested, but visually inspected, and found to be in satisfactory installation and condition at the time of inspection.

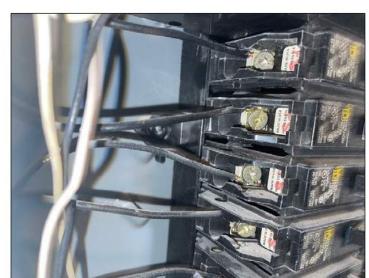
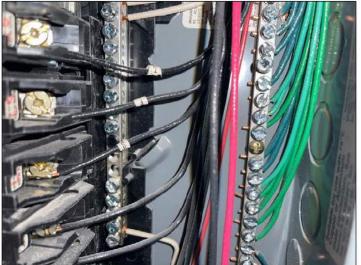
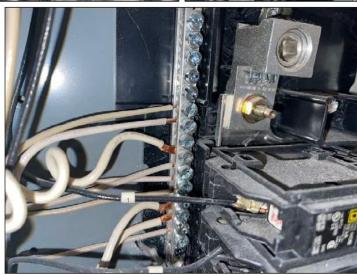
• The non-metalic sheathed cable (Romex) conductor material for the 120-volt circuits in the main electrical service panel was copper. The conductor material for the 240-volt circuits rated above 30 amps was copper or aluminum. Solid core or stranded aluminum for a dedicated 240v-30amp circuit or above is standard and acceptable.

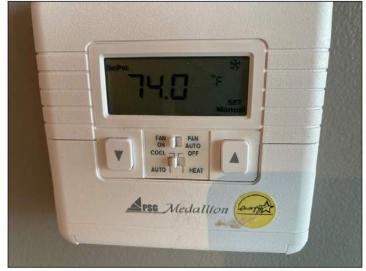
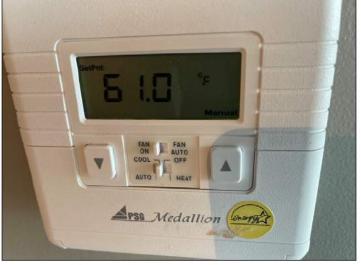
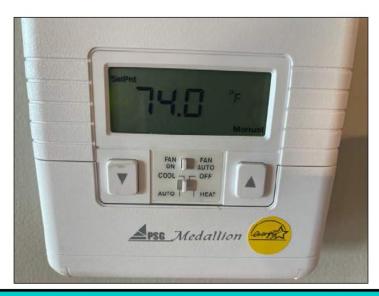
Master bedroom thermostat

• The Air Conditioning was controlled by one Programable thermostat. The Thermostat was fastened securely to the wall, activated the HVAC unit, and appeared to be in serviceable condition. The inspector takes three pictures of the thermostat. The first picture is to show all the settings on the thermostat and the current setting, before the inspector operates it. Second picture shows the setting used to make the Air Conditioning unit run. Third picture shows that the inspector has reset the thermostat back to the original setting after operation.

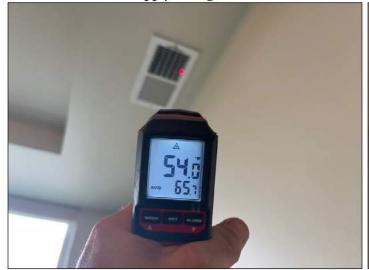
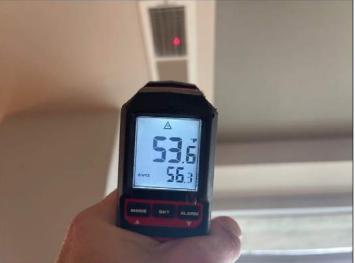
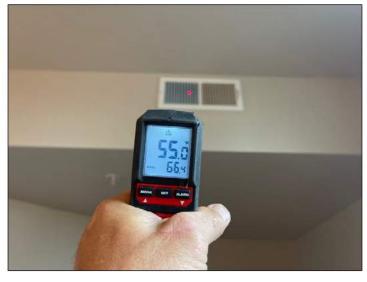
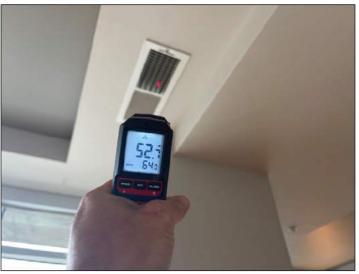
• Temperatures were taken at the registers. Each register showed a temperature drop which indicates that the unit was cooling as intended. The pictures shown are the temperature readings at the supply air register.

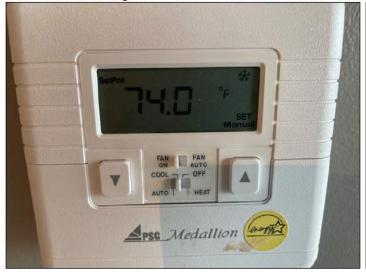
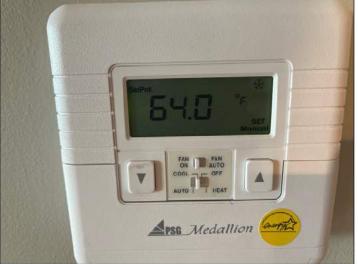
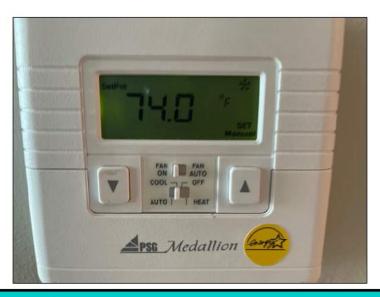
Kitchen thermostat

• The Air Conditioning was controlled by one Programable thermostat. The Thermostat was fastened securely to the wall, activated the HVAC unit, and appeared to be in serviceable condition. The inspector takes three pictures of the thermostat. The first picture is to show all the settings on the thermostat and the current setting, before the inspector operates it. Second picture shows the setting used to make the Air Conditioning unit run. Third picture shows that the inspector has reset the thermostat back to the original setting after operation.

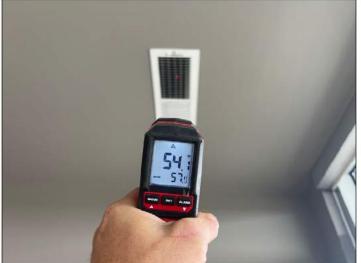
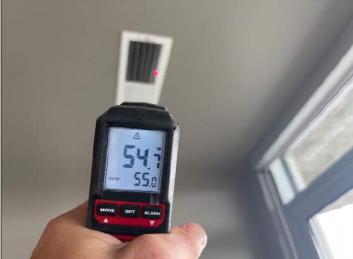
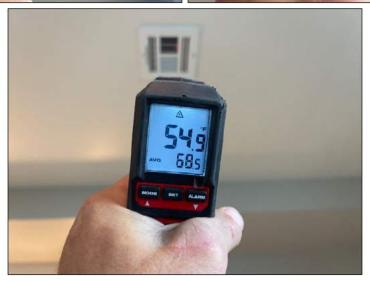
• Temperatures were taken at the registers. Each register showed a temperature drop which indicates that the unit was cooling as intended. The pictures shown are the temperature readings at the supply air register.

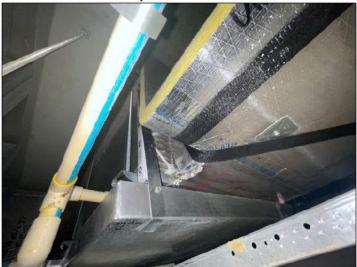
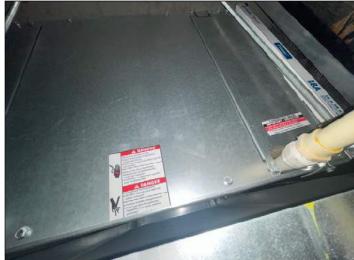
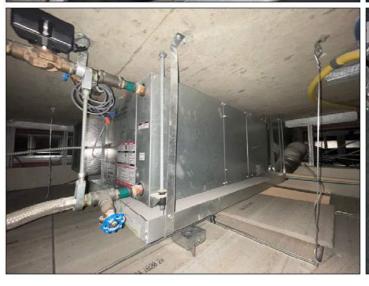
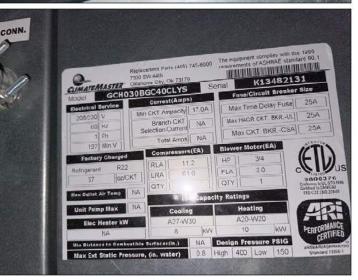
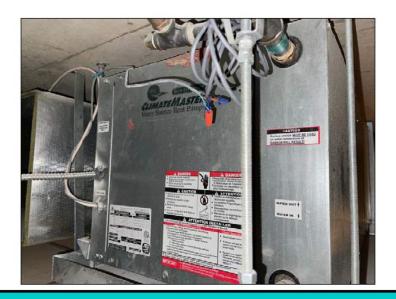
• A fan coil unit (FCU), is a device that uses a coil and a fan to either heat or cool a room. Recirculated indoor air moves over the coil, which either heats or cools the air before pushing it directly back out into the room.

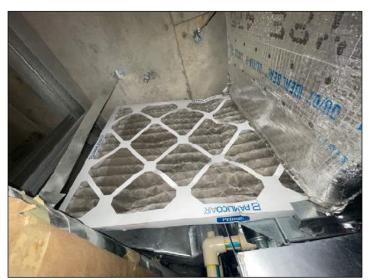
The HVAC system was equipped with an air filter. It was reasonably clean and properly secured into position.

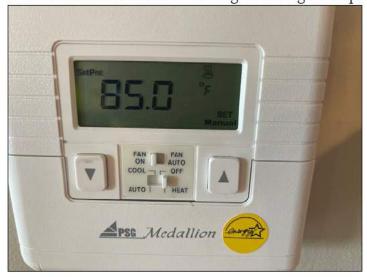
X F	• The Air Conditioning was controlled by one Programable thermostat. The Thermostat was fastened securely to the wall, activated the HVAC unit, and appeared to be in serviceable condition. The inspector takes three pictures of the thermostat. The first picture is to show all the settings on the thermostat and the current setting, before the inspector operates it. The second picture shows the setting used to make the Furnace heat up. The third picture shows that the
	inspector has reset the thermostat back to the original setting after operation.

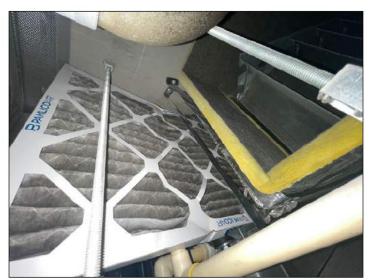
The HVAC system was equipped with an air filter. It was reasonably clean and properly secured into position.

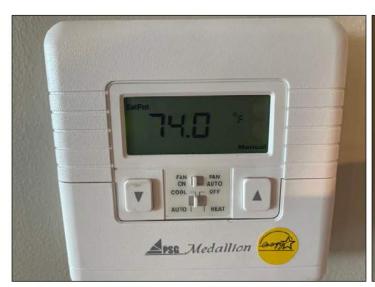
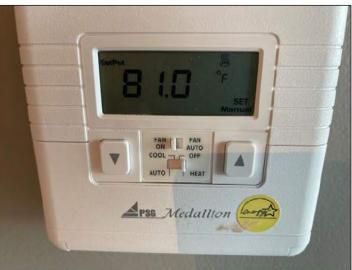
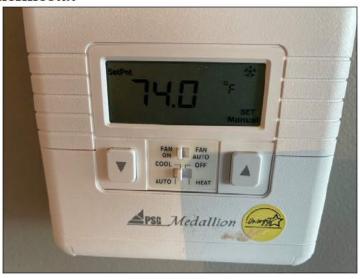
Kitchen thermostat

• The Air Conditioning was controlled by one Programable thermostat. The Thermostat was fastened securely to the wall, activated the HVAC unit, and appeared to be in serviceable condition. The inspector takes three pictures of the thermostat. The first picture is to show all the settings on the thermostat and the current setting, before the inspector operates it. The second picture shows the setting used to make the Furnace heat up. The third picture shows that the inspector has reset the thermostat back to the original setting after operation.
